Degradation of GNSS Accuracy by Multipath and Tree Canopy Distortions in a School Environment

Victus N. Uzodinma* and Uchechukwu Nwafor

Department of Geoinformatics and Surveying
University of Nigeria, Enugu Campus

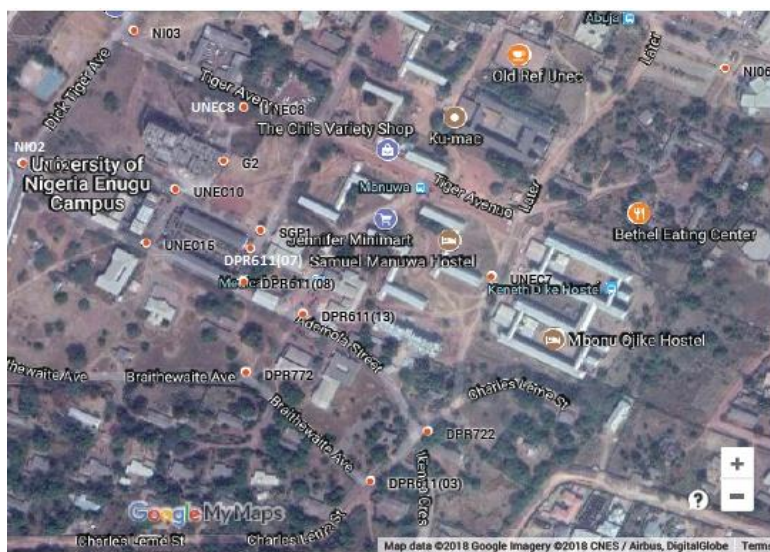
Figure 2: Aerial view of the study area (part of UNEC) with the 15 controls

The study area is a semi-urban setting characterised by local environmental features such as trees, buildings, tall fences, electric poles and high tension electric lines (Fig. 2). These features are suspected to limit the accuracy in GNSS positioning by factors such as multipath and tree canopy.

The fifteen stations used for the study and the environmental features surrounding them are shown in Table 1 and Figs 1 to 6. At the time some of the controls were established, those obstructing features were non-existent. A good example is G2 station (Fig 3) which was established in an open field and served as an important national geodetic control for high standard surveys and researches but recently, a two storey building was erected within six metres of it.
