Strength and Ductility of GFRP Strengthened Corrosion Damaged RC Columns

ABSTRACT---- *This paper presents the results of an experimental investigation to examine the effectiveness of Glass Fibre Reinforced Polymer (GFRP) wraps on corrosion damaged high strength concrete columns. A total of fourteen specimens of 150mm diameter and height of 600 mm were cast and tested. Each of the seven specimens were subjected to 0%, 15% and 30% level of corrosion-damage and in that one column specimen were used as corroded control. Glass fibre reinforced polymer wraps were used with different configurations such as CSM, UDC and WR. The wrapping was done with 3 mm and 5 mm thickness for each material. All the columns were tested under monotonic loading up to failure, in a loading frame of capacity 2000 kN. Necessary measurements were taken for each load increment. The findings concluded that GFRP wrapped corrosion-damaged concrete columns showed considerable enhancement in the load carrying capacity, deflection and ductility than the control concrete columns.*

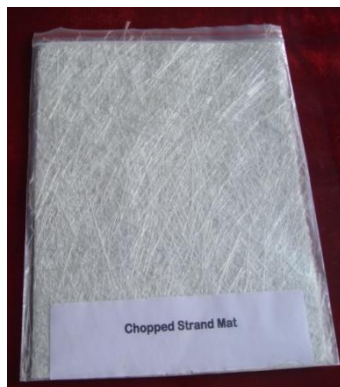
Figure. 1 Chopped Strand Mat Fabric

1. Chopped Strand Mat (CSM)
2. Uni-directional Cloth (UDC)
3. Woven Rovings (WR)

The glass fibres used for the study are shown in Figures 1 to 3.

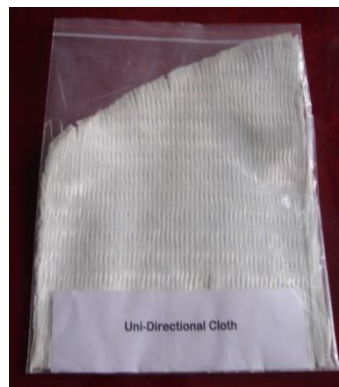
Figure. 2 Uni-Directional Cloth Fabric

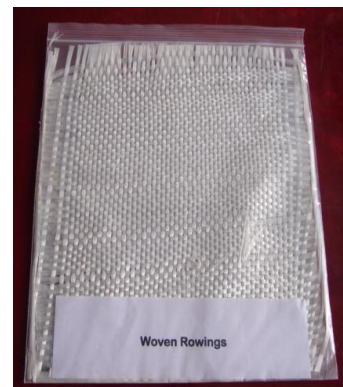
Figure. 3 Woven Rovings Fabric

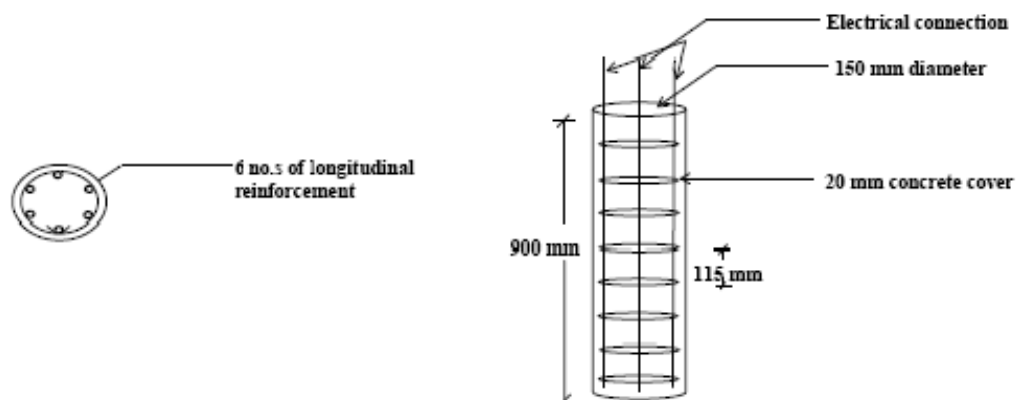
All the specimens were 150 mm in diameter and 900 mm in height. The specimens were provided with six bars of 8 mm diameter as longitudinal reinforcement. Each specimen also contained 6 mm diameter ties at a spacing of 115 mm c/c. The longitudinal bars were kept protruded from the column face to accommodate the electrical connections for accelerated corrosion. The details of specimens are shown Figure. 4.

Figure 4: Column Details

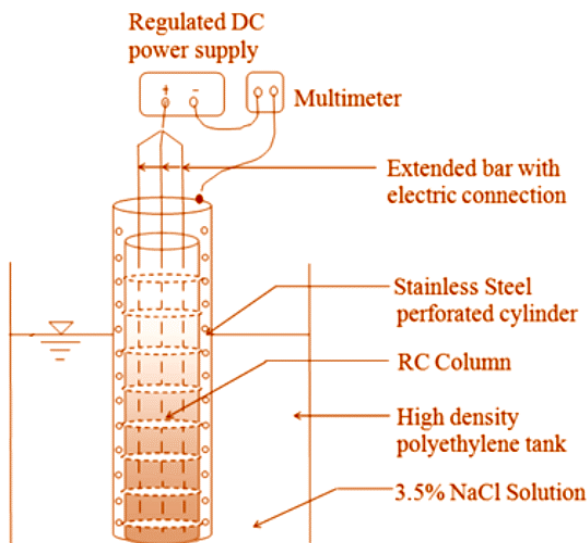
A schematic representation of the corrosion testing is shown in Figure.5. The columns were subjected to accelerated corrosion. The columns were kept immersed in 3.5% NaCl solution in a high-density polyethylene tank. The columns were immersed for a day to ensure full saturation condition. The direction of the current was arranged so that the reinforcement cage served as the anode while stainless steel perforated cylinders, acted as counter electrode. The accelerated corrosion process was achieved by applying a power supply with an output of 32 V and 11 amps. High voltage was used to accelerate the corrosion and shorten the test period. Two levels of corrosion damage, 15% and 30% were induced. The time for corrosion can be estimated by the Faraday's equation,

Figure.5: Schematic View of Accelerated Corrosion Set-up

where Δw = mass loss due to corrosion, A_m = atomic mass of iron (55.85 g), I = corrosion current in amps, t = time since corrosion initiation (sec), Z = valency (assuming that most of rust product is due to Fe (OH) 2, Z is taken as 2), F = Faraday's constant [96487coulombs (g/equivalent)]. The corrosion activity was monitored for the columns by measuring the corrosion potential in accordance with the ASTM procedure.

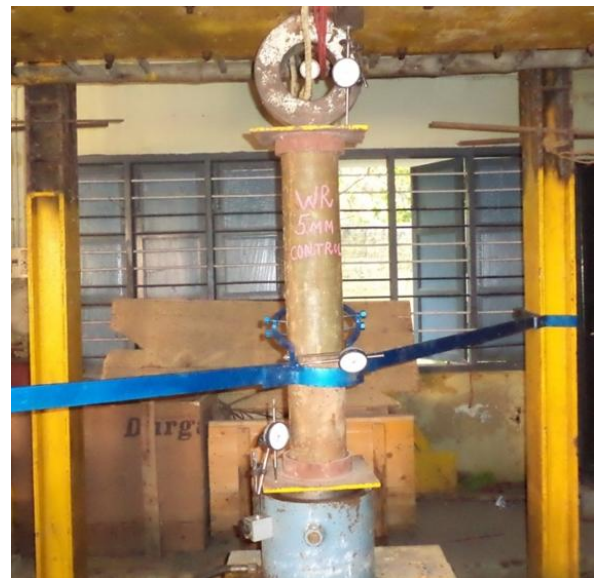
All the specimens were tested in a loading frame of capacity 2000 kN. To measure the axial compression of the column specimen, two deflectometers with a least count of 0.01mm were fitted at top and bottom of the specimen. A lateral extensometer was provided at mid-height of the column to measure the lateral strain. Figure 6 shows the experimental test set up and instrumentation provided for the test specimens.

Figure 6: Test Set-up

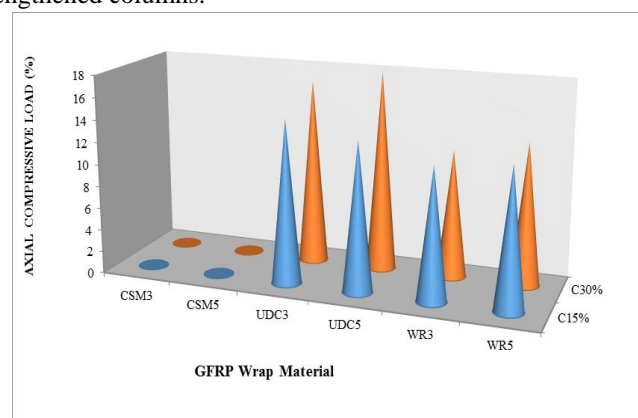
The effect of GFRP wrap material corresponding to their thickness was calculated by considering CSMGFRP wrapped columns as reference specimen and is presented in Figure.7.

Figure 7. Effect of GFRP Wrap Material on Load Carrying Capacity of Corrosion-Damaged Columns

The UDCGFRP wrapped corrosion-damaged columns resulted in higher ultimate load carrying when compared with CSMGFRP of same thickness. The UDCGFRP wrapped corrosion-damaged columns showed an increase in ultimate axial strength in the range of 15.54% to 19.62%. For columns subjected to 30% level of corrosion damage, UDCGFRP wrapped column showed an increase in load carrying capacity in the range of 15.54% and 19.62%.

The columns wrapped with WRGFRP showed a minimal increase in the range of 2.22% to 4.30% in compressive strength when compared to CSMGFRP wrapped columns. For columns subjected to 30% level of corrosion damage, WRGFRP of 3mm and 5mm thickness showed a marginal improvement in ultimate strength by 2.91% and 4.32% respectively. From the results, it is obvious that UDCGFRP provided the most effective confinement to corrosion-damaged concrete columns.

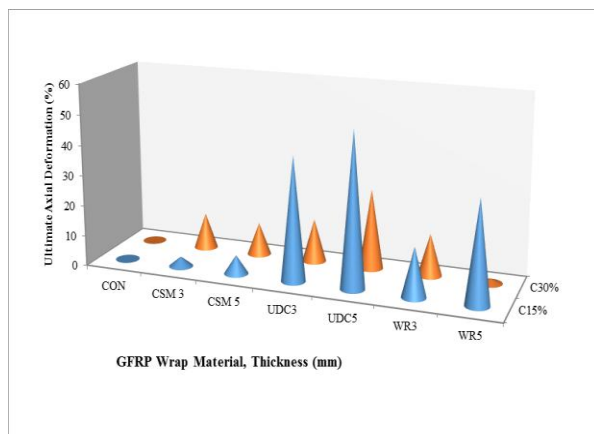
The effect of axial deformation on various levels of corrosion-damage is shown in Figure.8. The ultimate axial deformation was decreased due to the corrosion damage induced in the columns. The ultimate axial deformation of

Figure 8. Effect of Various Levels of Corrosion-Damage on Axial Deformation of GFRP Wrapped Columns

column CD 15 CON and CD 30 CON were reduced by 1.59 % and 2.54 % respectively when compared to the non-corroded unwrapped control column NC CON. The specimens with CSMGFRP, UDCGFRP and WRGFRP wrapping showed a decrease in axial deformation by 4.14% to 10.19%, 12.10% to 22.92% and 20.38% to 35.98% in comparison with control column.

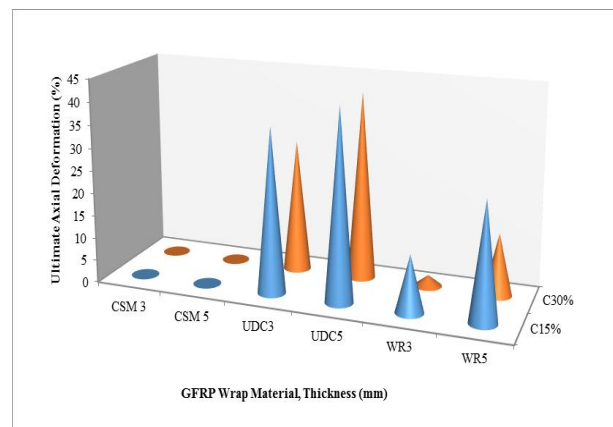
The effect of GFRP wrap material on ultimate axial deformation is shown in Figure.9. The columns wrapped with WRGFRP showed a nominal decrease in the range of 10.80% to 11.92% in axial deformation in comparison with CSMGFRP wrapped columns. For columns with 15% level of corrosion damage, WRGFRP showed a decrease in ultimate axial deformation in the range of 16.94% to 23.34% in comparison with CSMGFRP wrapped columns. For columns subjected to 30% level of corrosion damage, WRGFRP showed a decrease in axial deformation in the range of 23.44% and 28.72% in comparison with CSMGFRP wrapped columns.

Figure 9. Effect of GFRP Wrap Material on Axial Deformation of Corrosion-Damaged Columns

The UDCGFRP wrapped corrosion-damaged columns showed an decrease in ultimate axial deformation by 5.96% to 6.08%. The UDCGFRP wrapped column exhibit an decrease in axial deformation by 8.30% to 8.71 for 15% level of corrosion damage. For columns subjected to 30% level of corrosion-damage, the GFRP wrapping decrease the ultimate axial deformation in the range of 8.62% to 14.18%.

A noteworthy behaviour was found in UDCGFRP material over other materials. This was because fibres in UDCGFRP where so oriented as to effectively confine the concrete.

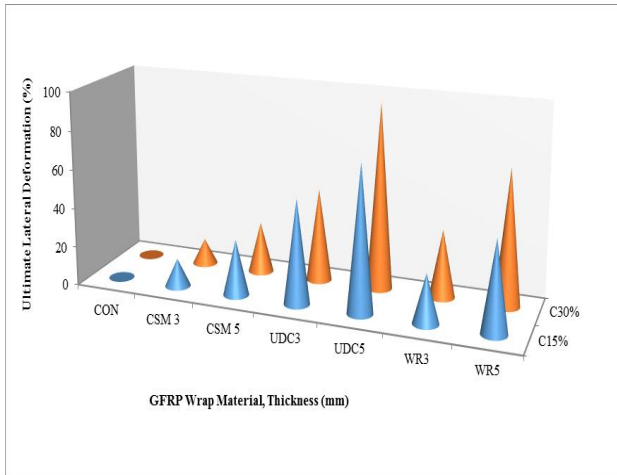
The effect of GFRP wrapping on ultimate lateral deformation for various levels of corrosion damage is shown in Figure. 10. The ultimate lateral deformation in corroded column was decreased by 9.68% and 21.94% for 15% and 30% level of corrosion damage.

Figure 10. Effect of Various Levels of Corrosion-Damage on Lateral Deformation of GFRP Wrapped Columns

For 15% level of corrosion-damage, the columns wrapped with CSMGFRP, UDCGFRP and WRGFRP exhibit an decrease in lateral deformation by a maximum of 10.97%, 54.84% and 26.45% respectively when compared with the control column.

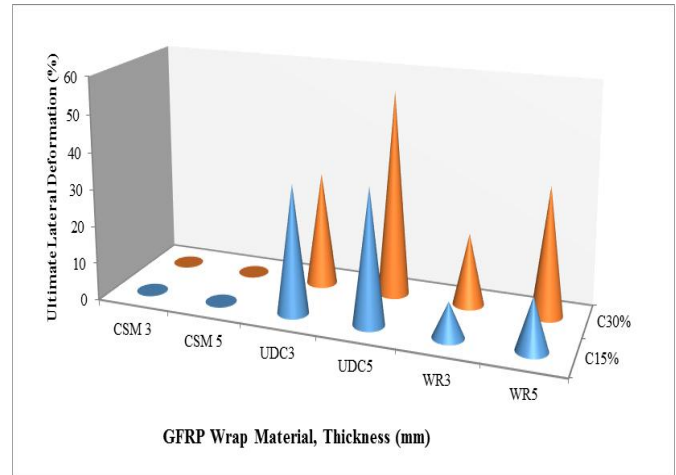
The influence of GFRP wrap material on ultimate lateral deformation is presented in Figure.11.

Figure 11. Effect of GFRP Wrap Material on Lateral Deformation of Corrosion-Damaged Columns

The columns wrapped with WRGFRP showed a decreased in the range of 6.92% to 13.96% in lateral deformation when compared to CSMGFRP wrapped columns. For columns subjected to 15% level of corrosion damage, WRGFRP showed a decreased in ultimate lateral deformation by 13.95%. For columns subjected to 30% level of corrosion damage, WRGFRP showed decrease in lateral deformation in the range of 6.92% to 9.64%. For columns subjected to 15% and 30% level of corrosion damage, UDCGFRP wrapping decreased the ultimate lateral deformation by 39.53% and 39.15%.

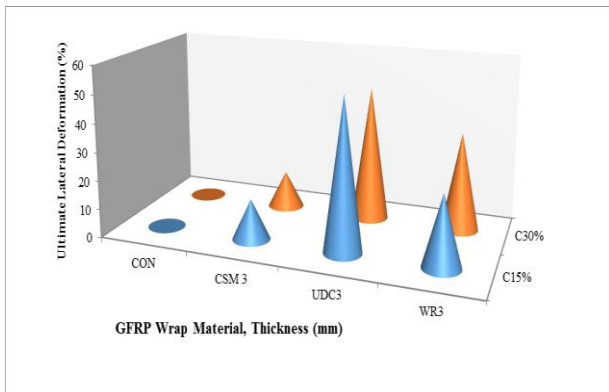
The influence of GFRP wrap thickness on lateral deformation is presented in Figures. 12 and 13.

Figure 12. Effect of 3 mm Thick GFRP Wrap on Lateral Deformation of Corrosion-Damaged Columns

For test specimens subjected to 15% corrosion damage level, 3 mm thick CSMGFRP, UDCGFRP and WRGFRP showed a decrease in lateral deformation by 14.29%, 52.86% and 30%. For specimens subjected to 15% level of corrosion damage, 5 mm thick CSMGFRP, UDCGFRP and WRGFRP showed a decrease in lateral deformation by 22.85%, 71.43% and 40%.

For 30% level of corrosion damage, the columns with 3mm thick GFRP wrapping showed a decrease in ultimate lateral deformation by 32% for CSMGFRP, 66.94% for UDCGFRP and 40.5% for WRGFRP and those with 5mm thick GFRP wrapping exhibit a decrease in lateral deformation by 37.10% for CSMGFRP, 90.90% for UDCGFRP and 50.41% for WRGFRP.

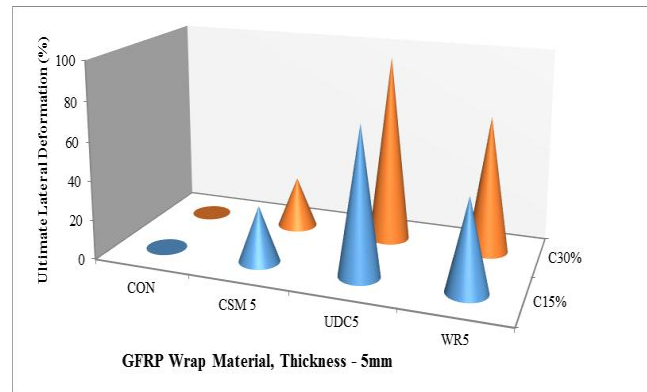
Figure 13. Effect of 5 mm Thick GFRP Wrap on Lateral Deformation of Corrosion-Damaged Columns

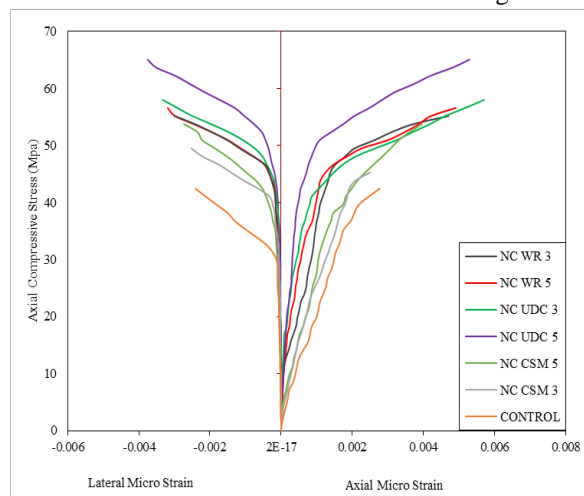
The stress-strain curves for columns with 0% and 30% level of corrosion damage is shown in Figures. 14 to 16.

Figure 14. Stress-Strain Response for 0% Level of Corrosion-Damaged Columns

The corroded wrapped columns experienced a large strain value. The corroded control column failed at reduced stress with increase in level of corrosion damage. On increasing the thickness of GFRP wrapping, the stress level moved up to a certain extent. The UDCGFRP wrapping performed well in both corroded and non-corroded columns.

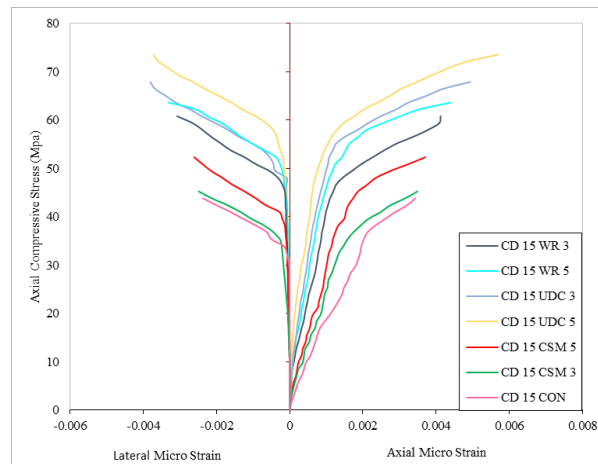
Figure 15. Stress-Strain Response for 15% Level of Corrosion-Damaged Columns

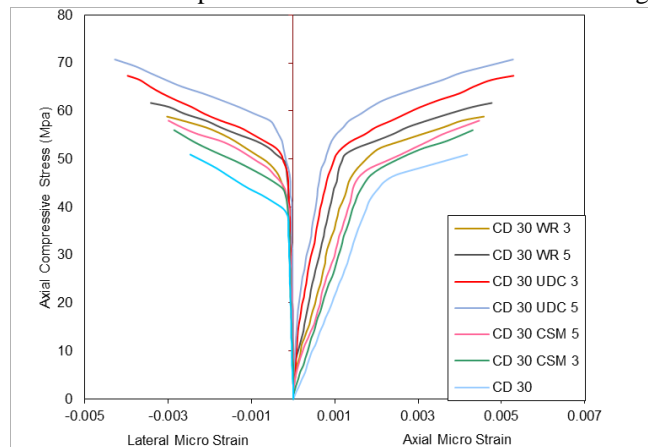
Figure 16. Stress-Strain Response for 30% Level of Corrosion-Damaged Columns
