Evaluation Methodology on Vibration Serviceability of Bridge by using Non-Contact Vibration Measurement Method

ABSTRACT— *In order to evaluate vibration serviceability by means of non-contact vibration meter, serviceability of existing bridge were experimentally evaluated by using laser vibration meter, and the methodology for the serviceability were also proposed. Test results were analyzed and compared with evaluation results acquired by using accelerometer and LVDT. To testify accuracy of natural frequency by vibration data through laser vibration meter, it was compared with that acquired by using accelerometer. According to test and comparison results, it is showed that serviceability can be evaluated properly enough from the tolerance curve of Reiher-Meister for the estimated acceleration that can be calculated by the numerical differentiation of measured velocity.*

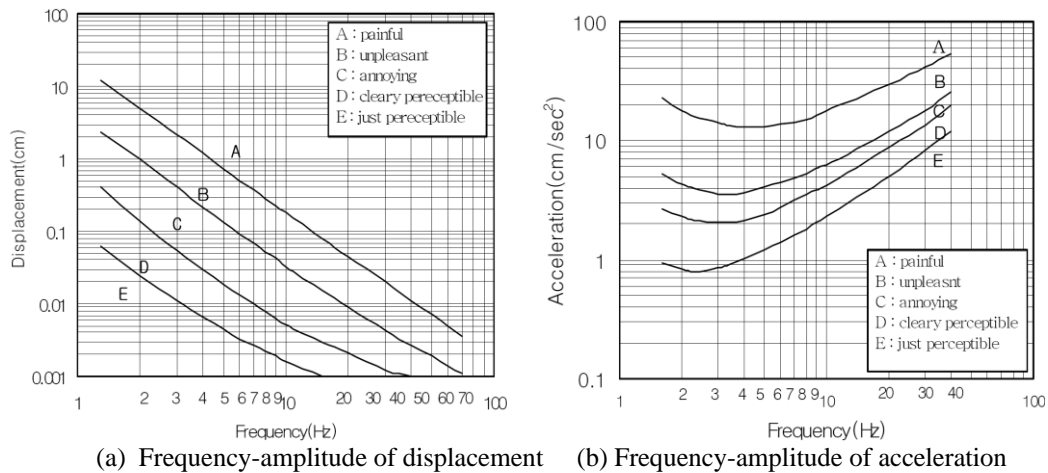
Accordingly, this paper adopts the Reiher-Meister curves for the assessment of the vibrational serviceability of bridges. Figure 2 shows the Reiher-Meister's tolerance curves with respect to the amplitudes of displacement (Figure 2(a)) and acceleration (Figure 2(b)). The horizontal axis represents the frequency and the vertical axis stands for the amplitude of displacement and acceleration. These curves are the results of large scale tests and assess the vibrational serviceability by five degrees of perception from "just perceptible (E)" to "painful (A)". It can be observed that the sensitivity to the amplitude of displacement increases with higher frequencies whereas the sensitivity to the amplitude of acceleration weakens at higher frequencies (Kim, 2006; Kim et al., 2002).

Figure 2: Tolerance curves of Reiher-Meister

The velocity response according to the traffic was measured using the non-contact vibrometer. In addition, the acceleration and displacement were measured by installing accelerometers and LVDTs. The measurement of these responses is necessary if the Reiher-Meister curves shown in Figure 2 are used to assess the vibrational serviceability of the structure. However, the use of the LDV selected as non-contact vibrometer measures the velocity of the structure, which means that the displacement should be obtained by numerical integration of the velocity and the acceleration should be estimated by numerical derivation of the velocity. Accordingly, it appears that the accuracy of the so-estimated acceleration and displacement should be verified. Therefore, experimental verification will be conducted by exploiting the data measured on the bridge. To that goal, the acceleration and displacement measured by the accelerometers and LVDTs will be compared to the values obtained by numerical derivation and numerical integration of the measurements provided by the non-contact LDV. Here, the PC program developed for the establishment of the non-contact vibration measurement system is used for the data acquisition and frequency analysis. The numerical integration and derivation are performed in the time domain.

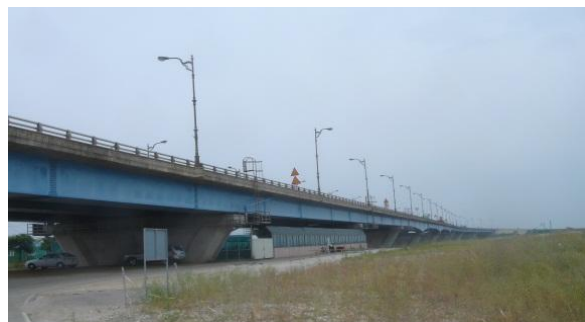
The bridge selected for the verification of the performance of the vibrometer is Sab-Kyo Bridge, located on national road 34 in Korea (Figures. 3 and 4). Sab-Kyo Bridge is a steel box girder bridge with length of 560 m and width of 20.1 m. It is a ten-span bridge with two central spans of 80 m and four spans of 50 m at both sides. The measurement spot is located at the bottom of the steel box of the left-hand side 50 m-span (A1-P1) and the height from the ground to the bottom of the steel box runs around 440 cm.

Figure 3: Side view of Sab-Kyo bridge

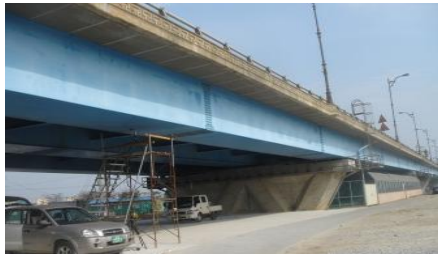
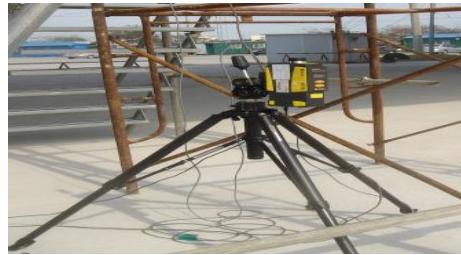
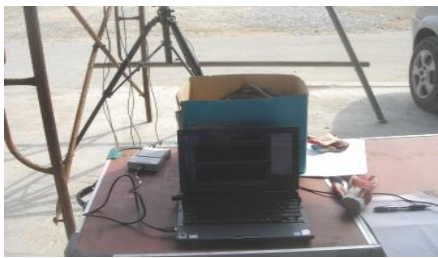
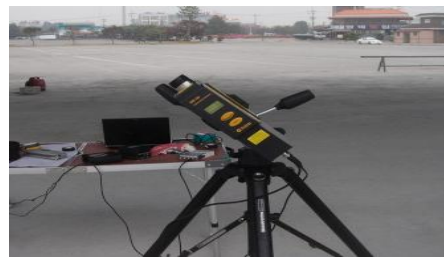
Figure 5: Test set-up

(a) Conceptual drawing of measurement

(b) Scaffold set-up and accelerometer installation

(c) Vibration meter set-up

(d) PC program setting

(e) Vibration measurement

As listed in Table 2, the test variables are the duration and angle of measurement, and the eventual attachment of a reflector. A total of 10 cases are assumed. Here, the selection of the measurement duration as test variable has been governed by the consideration of the passage of an arbitrary vehicle with unspecified weight during the execution of the ambient vibration test. The angle of measurement stands for the discharge angle of the laser beam with reference to the straight line perpendicular to the bottom of the steel box as shown in the test setting of Figure 5.

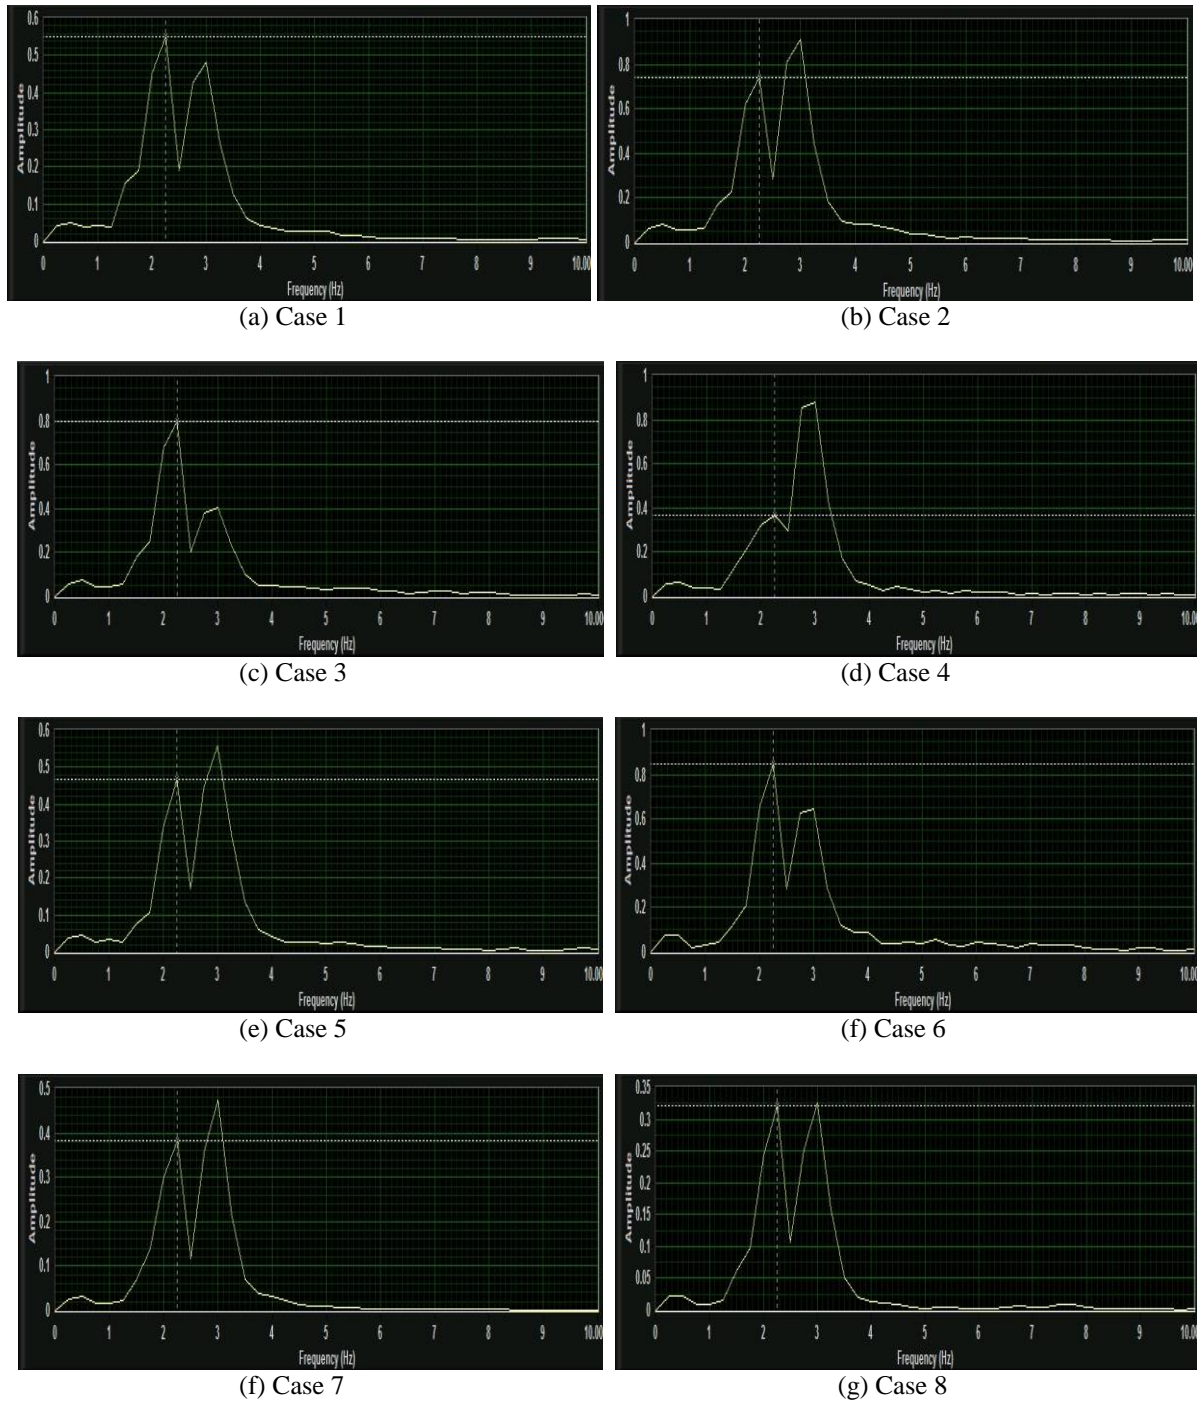
Even if the duration of measurement was varied from 5 minutes to a maximum of 30 minutes in order to consider the passage of unspecified vehicles, all the measurements resulted in an identical natural frequency of 2.12 Hz as 1st natural frequency (Figure 6). The identical natural frequency obtained through the varying durations of measurement can be explained by the following two reasons. The traffic was relatively poor during the period of the test and, in view of the measured signals, the absence of vehicles inducing relatively large amplitude of vibration could not provoke interaction of interest. In addition, the longest span Sab-Kyo Bridge reaches 80 m and its side spans are 50 m long, which classify it as a short-to-medium span bridge. Accordingly, the effect of wind loads on the dynamic characteristics of the bridge remains insignificant compared to long-span bridges like cable-stayed bridges. In the ambient vibration test, the effects of the white noise-like wind and traffic loads remained relatively small and led to identical natural frequency despite the change of the duration of measurement.

Figure 6: Frequency analysis results

The natural frequency measured with respect to the given tilt angles was 2.12 Hz for all the cases from Case 6 to Case 10, and corresponded to the natural frequency measured when the laser beam was perpendicular to the measurement surface. Accordingly, the amount and path of the reflected wave generated when the laser beam is discharged obliquely to the measurement surface are seen to have insignificant effect on the measurement of the natural frequency.

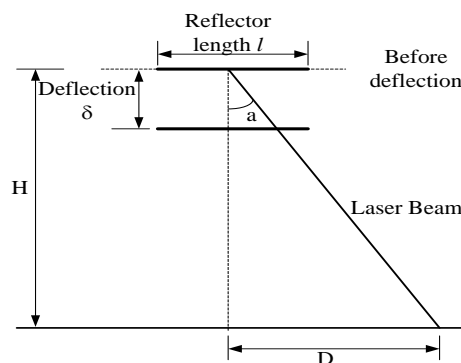
For Case 10 with a tilt angle of 50° , the location of the focus deviated slightly from the exact position and degraded the measurement sensitivity. However, such conditions did not affect the frequency analysis. This can be explained by the very satisfactory state of the surface of the steel box of Sab-Kyo Bridge. However, in general, the measurement angle, a , is determined with respect to the geographical features of the site. If δ is the maximum expected deflection, the minimum length, l , of the reflector is determined by Equation 1. Since the laser focus should be located within the reflector, the measurement sensitivity is maintained in the optimal state (Figure 7). For example, in the case of Sab-Kyo Bridge for which a maximum dynamic deflection of 10 mm was measured, the measurement height, H , is 4.4 m and the horizontal distance, D , from the reflector to the measurement location is 5.24 m leading to a measurement angle, a , of 50° (the distance of 5.24 m is assumed considering the topographical conditions). In this case, the minimum length, l , of the reflector should be approximately 24 mm to maintain optimal measurement sensitivity.

$$l = 2\delta \tan a = 2\delta \frac{D}{H} \quad (\text{Equation 1})$$

Figure 7: Determination of the length of the reflector for optimal measurement sensitivity

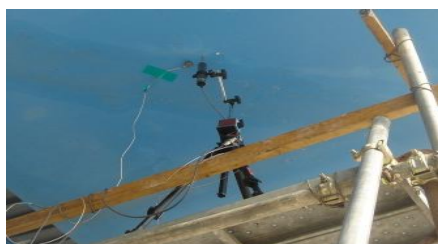
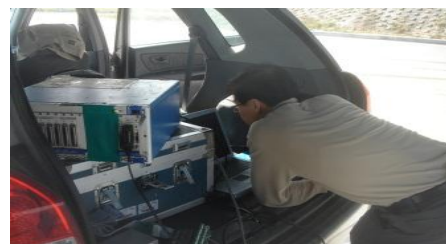
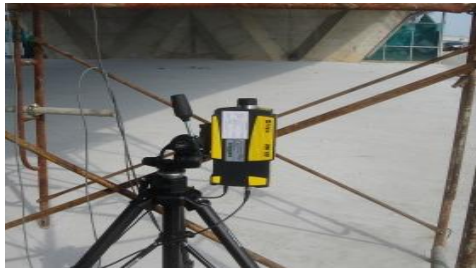
Figure 8: Test set-up

Since the height from the ground to the measurement spot runs around 4.4 m, a scaffold was installed to attach the accelerometer and LVDT. After their installation, the sensors were connected to a dynamic data logger and the setting was completed to measure the dynamic displacement and acceleration by setting the initial values of the program (Figure 8). The setting process of the LDV was identical to that applied for the feasibility test. Figure 8(d) illustrates the setting completed for the assessment of the vibrational serviceability of Sab-Kyo Bridge by adjusting the optimal laser focus. As shown in Figure 8(d), the measurement spot is identical for the accelerometer, LVDT and LDV to enable simultaneous measurement. The velocity is measured using the LDV and the results are compared with those obtained by the conventional contact-type vibration measurement method to verify experimentally the applicability of the non-contact vibrometer for the assessment of the vibrational serviceability of the in-service bridge.

(a) Accelerometer and LVDT

(b) Data logger set-up

(c) Vibration meter set-up

(d) Focus adjustment and measuring
