Investigating Shoreline Migration due to Sand Mining in Some Communities of Yenagoa Local Government Area using GIS and Remote Sensing

Alfred Wilson Opukumo* and Austin Oyinkuro Oki

Department of Geology, Niger Delta University
Wilberforce Island, Bayelsa State, Nigeria

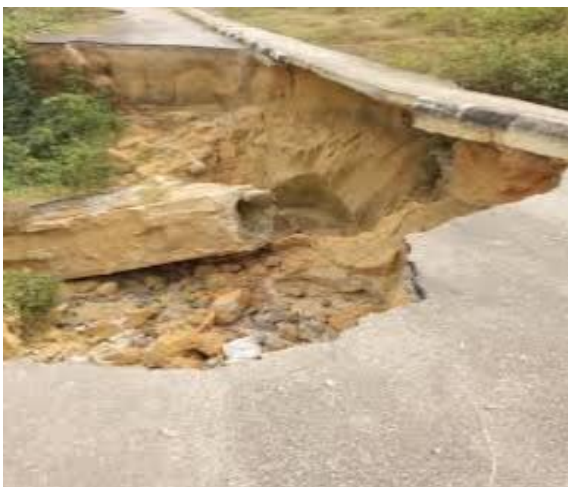
A study of mining sites revealed that damages to critical infrastructures (Fig. 3a). In some areas, erosion has been triggered near bridge abutments (Fig. 3b). These damages were observed to occur as moving heavy trucks loaded with tonnes of mined sand continuously exert excess weight or stress on both road infrastructure and weak grounds.

Fig. 3a. Road damage at Tombia caused by heavy vehicles laden with tonnes of sand

Onsite observations revealed irregular grounds and damaged roads around areas where river sand mining activities take place. These were the impressions of heavy-laden trucks used for the transportation of mined sands to end users.

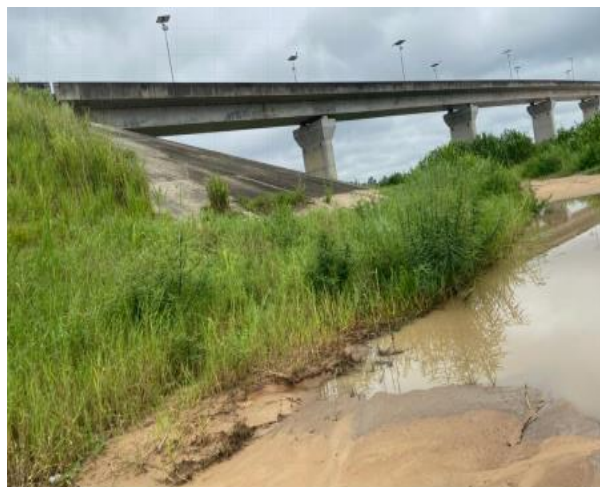
Fig. 3b. ground damage near Tombia – Agudama Ekpetiama bridge caused by heavy vehicles laden with tonnes of sand

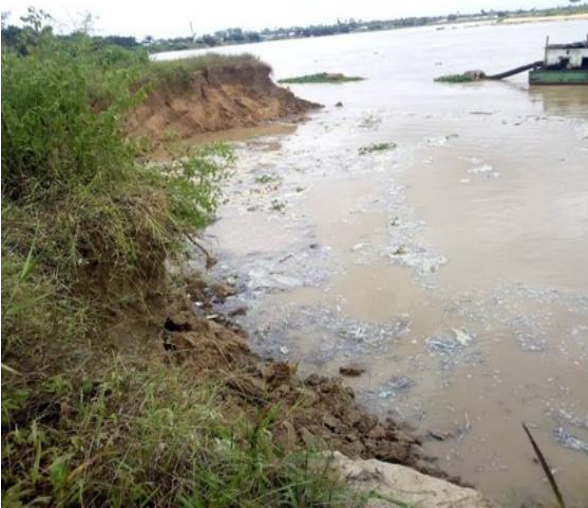
From physical observations also, it was noticed that some of the mining (both manually and mechanically operated) were sited relatively close to the shoreline. It is common knowledge that the sand extraction process creates holes (usually with unprotected walls) on the bottom of the river. These unprotected walls start falling off or collapsing and this extends to the shoreline causing shoreline collapse or erosion. The Figs. 4a & 4b show this scenario as captured at Famgbe and Obogoro communities, respectively.

Fig. 4a. River shoreline erosion due to dredging near to shoreline at Famgbe community

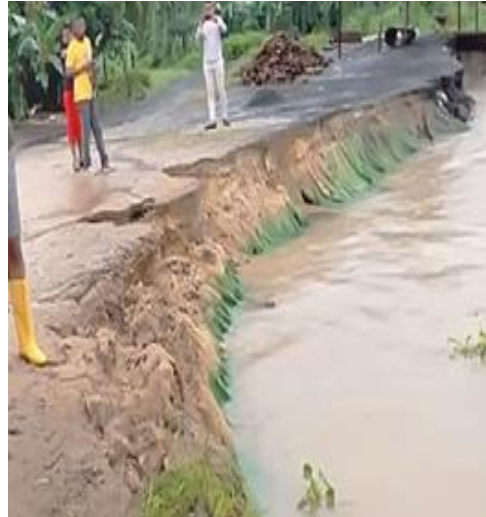
Fig. 4b. River shoreline erosion due to dredging near to shoreline at Obogoro community

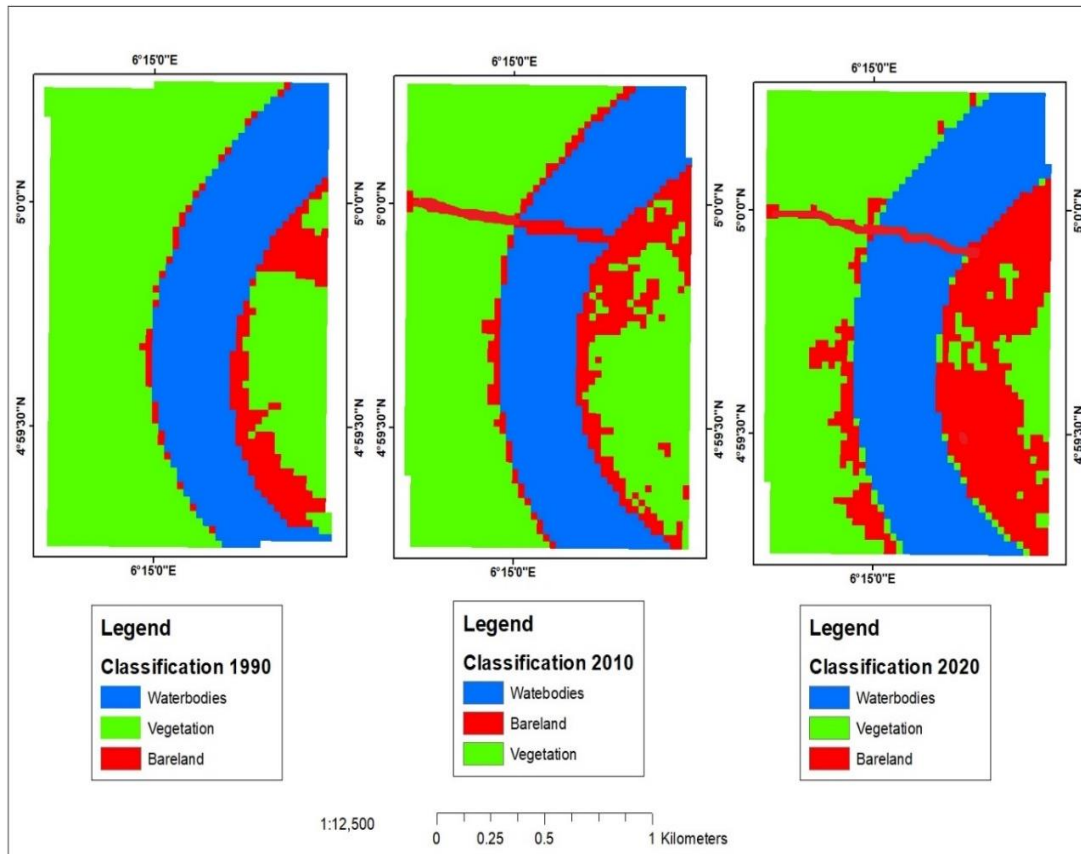
The land use maps generated from the integration of remotely sensed data with thematic features from land use models using satellite imagery for 1990, 2010, and 2020 (zone two) are presented as Fig. 5.

Fig. 5. Land use classification of zone two for 1990, 2010, and 2020.

The satellite imagery was processed and classified using a supervised classification scheme by assessing land-use patterns and categorizing them into three classes, namely water bodies, vegetation, and bare land areas based on the area covered. For each class, the estimated values for area covered are presented in Table 3 and graphically shown as Fig. 6. These values are also presented in terms of the percent area covered in Table 4.

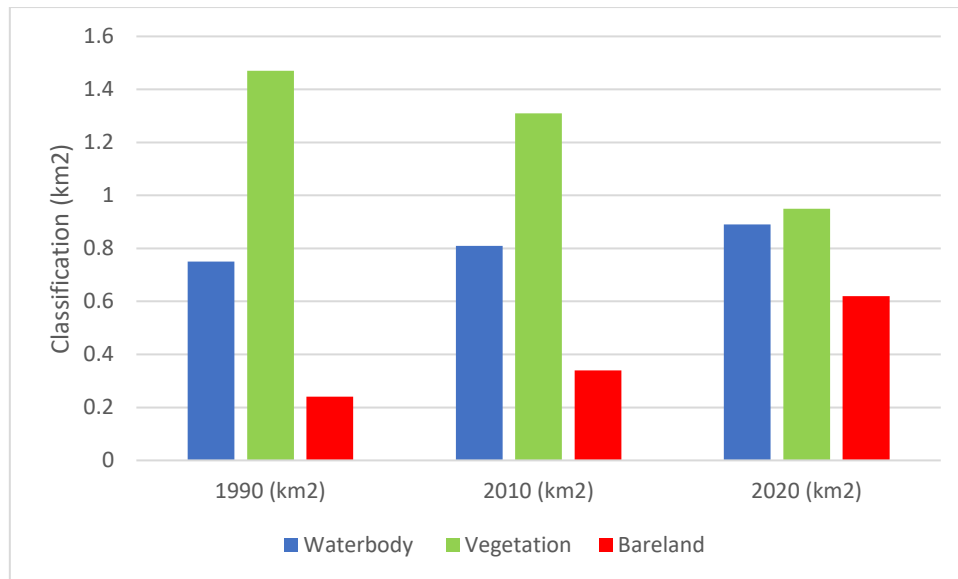
Fig. 6. Land use change from 1990 to 2010 and 2020.

The data presented in Tables 3 & 4 and Fig. 6 show clear evolution of all the three classes of waterbodies, vegetation, and bare land over the years. There is an increase in the measured area occupied by waterbodies from 1990 to 2020. This is an expansion of the river width as the banks continued to suffer erosion caused partly by the activities of sand mining. While vegetation area continued to decrease, the bare land area increases. Understandably, the vegetation area was depleted as the river sand mining business expanded, thus, more land area is captured as bare land. Although vegetation depletion could also result from other activities, e.g., burning. However, a walkover these sites was done and observation confirmed that all bare land areas were those occupied by sand mining activities.

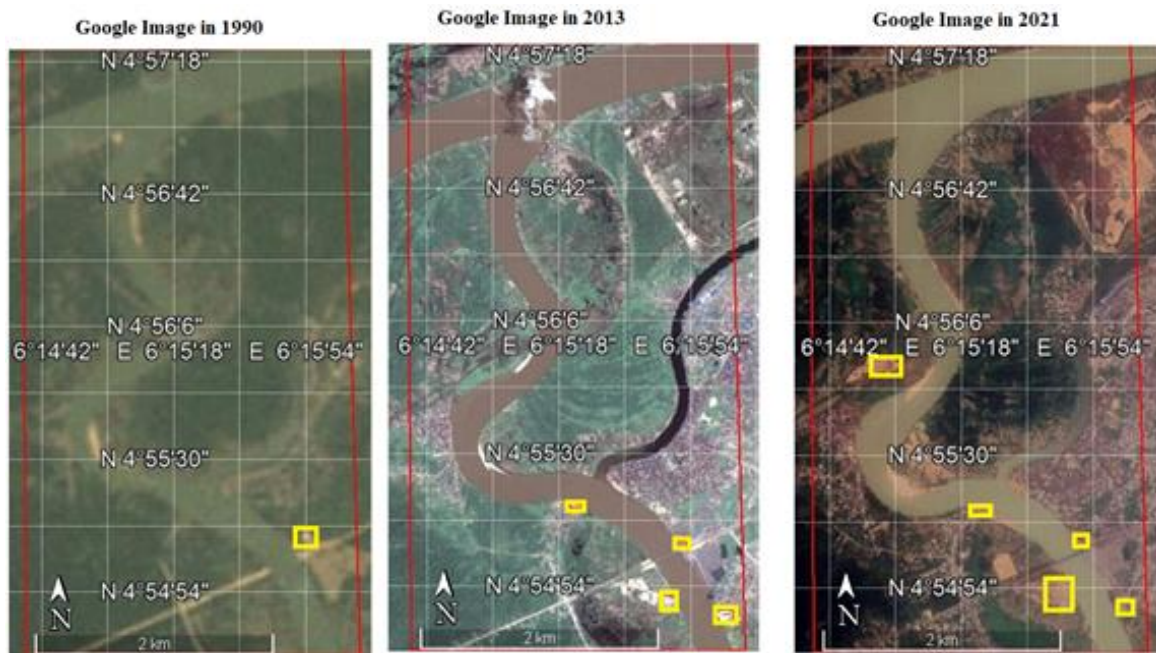
Fig. 7b. Zone one google earth historical images showing sand dumps from 1990 to 2021

Shoreline evolution maps and historic images of sand dumps for each of the zones under the study area are presented as Figs. 7a & 7b, respectively for zone one and Figures 8a and 8b, respectively for zone two.

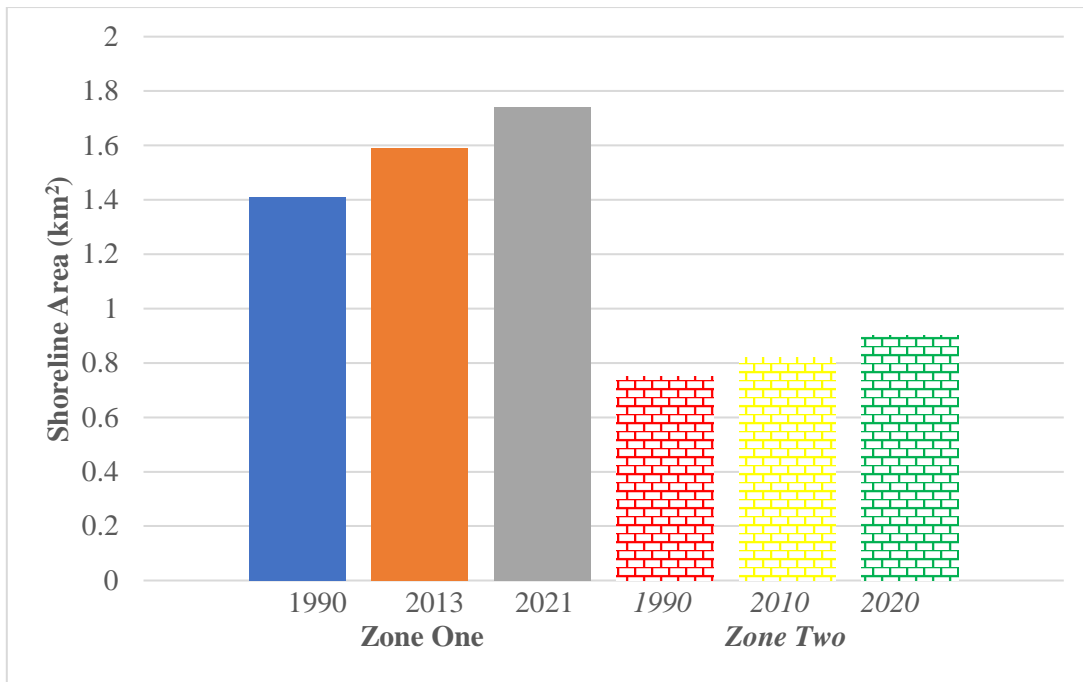
Fig. 9. Shoreline changes from 1990 to 2021

Zone One shows a wider shoreline area than Zone Two while the reverse is the case for dumpsite area. As earlier stated, there are increases over the years, in shoreline and dumpsite areas for both zones under study. While shoreline increases of 12.77% and 9.43% between the years considered were recorded in Zone One, increases of 9.33% and 9.73% were recorded for Zone Two. On the other hand, the increases in dumpsite areas were 135.27% and 130.54% for Zone One and 101.13% and 12.04% for Zone Two. Yet, less sand dumpsite area has resulted in Zone One than in Zone Two. That is, more river sand mining takes place in Zone Two. This might have been possible because of the difference in the extraction methods common in each zone, and the availability of free land space. While manual extraction method is used in Zone One, the mechanical extraction method prevails in Zone Two.

The shoreline and sand dump evolutions in terms of land area covered are summarized in Table 5. The estimated values are graphically shown as Figs. 9 to 11.

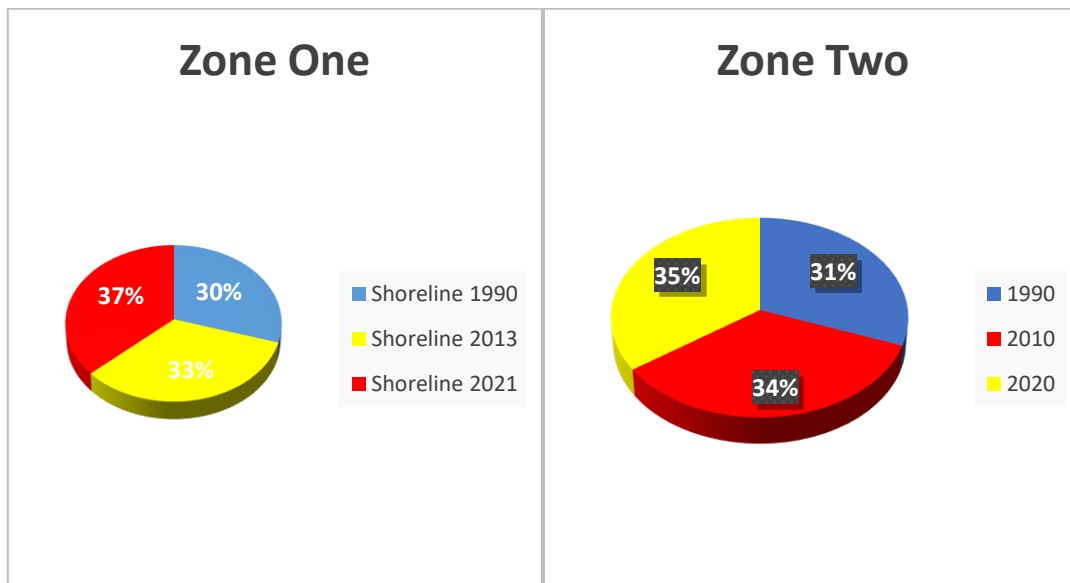
Fig. 10. Percentage shoreline changes from 1990 to 2021

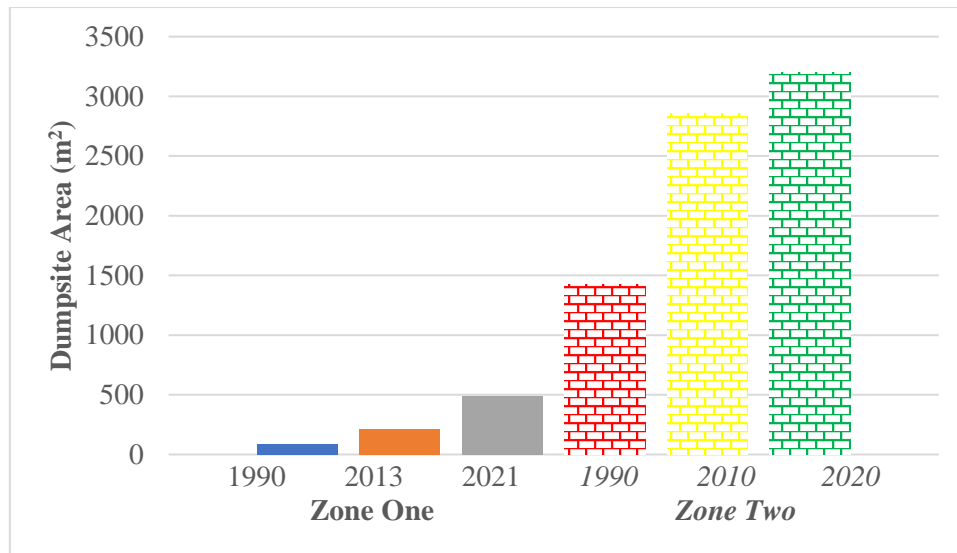
Fig. 9. Dumpsite area changes from 1990 to 2021

On the contrary, the rate of increase of dumpsite area did not directly relate to the rate of increase in shoreline area for both zones under consideration. This suggests that river sand mining is not solely responsible for shoreline evolution. Other processes prevalent within the river system (e.g., wave actions, erosion and accretion, etc.) contribute to its shoreline evolution.
